The Clock Spring composite repair sleeve and reinforcement system is uniquely designed for high pressure transmission pipelines. Made up of a pretensioned and pre-cured unidirectional e-glass composite coil, a high-modulus filler material, and a high lap-shear strength methyl methacrylate adhesive, it is proven to 8000 psi burst pressure, has a design life of beyond 50 years, and an installation history of more than 30 years, qualifying it as the first permanent repair in the industry.

## Clock Spring

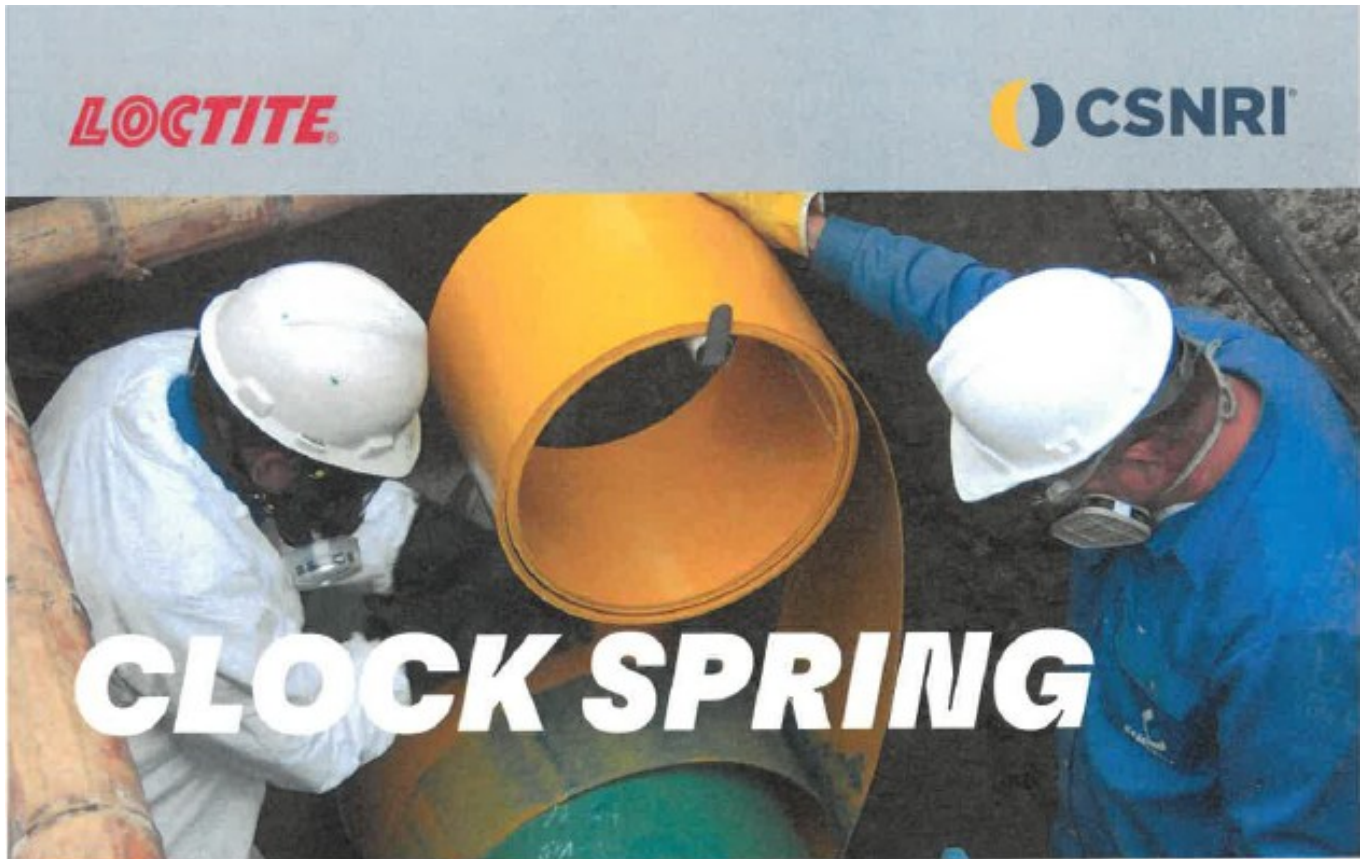
Each Clock Spring coil is made up of 8 layers, providing a repair with a higher failure pressure than the original pristine pipe. Designed to structurally reinforce and permanently restore external anomalies to beyond original pipe strength, the Clock Spring sleeve can repair a broad range of metal loss up to 80% depth, deformation and mechanical damage, and mill defects. Clock Spring is available in 4-inch through 56-inch diameter kits.
